# Inspection Report

## Ultimate Building & Pest

**74 Overall Drive, Pottsville, NSW, 2489**

## Pest And Building Inspection

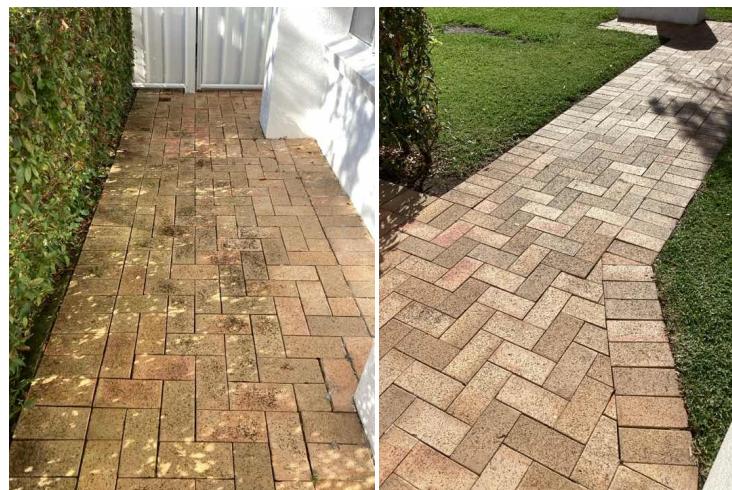
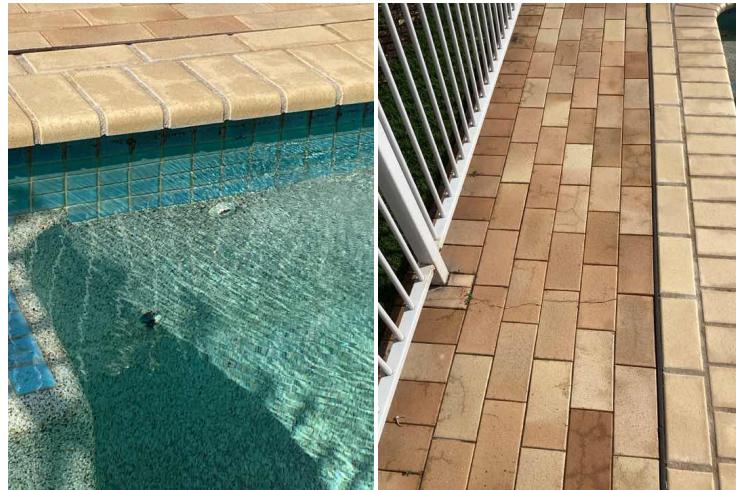
Surface raised and settled in some areas. This can cause water ponding. Relaying recommended.

Damaged pebble Crete to pool noted (minor)

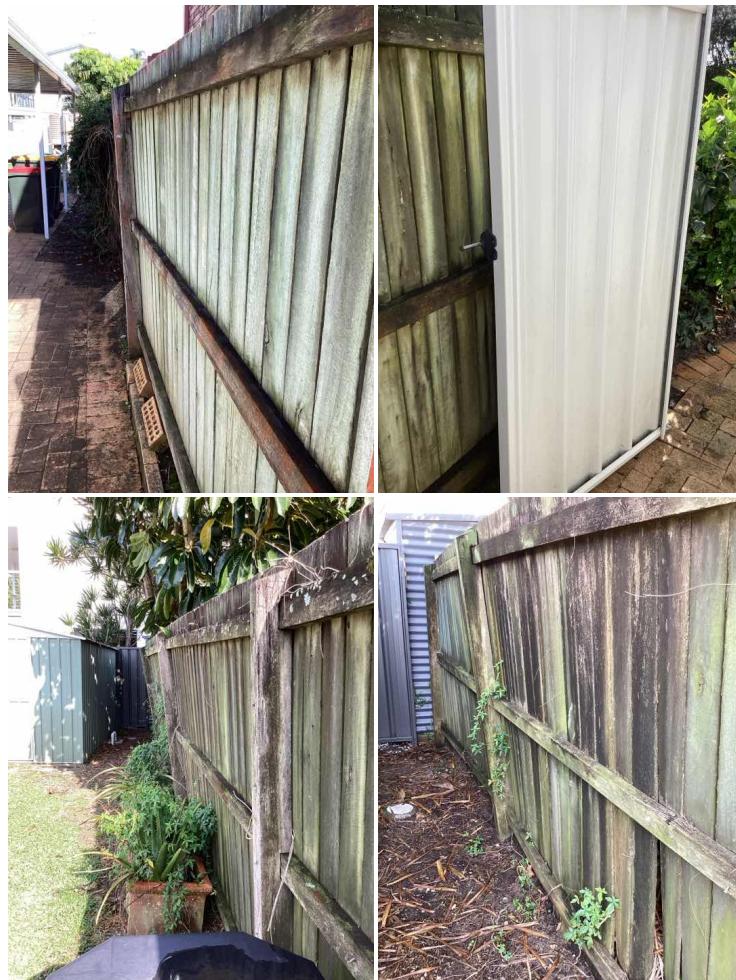
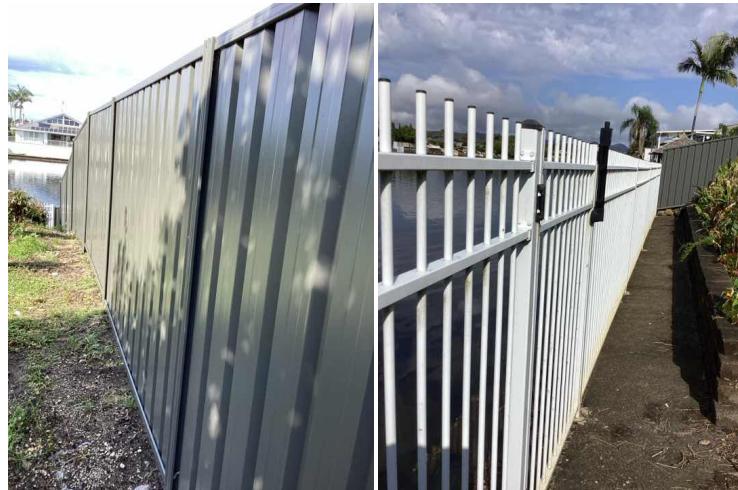
General age to fence components. General upkeep and maintenance required. A qualified fencing contractor should be engaged for repairs.

Fence rot/leaning. Repairs are required by a fencing contractor to avoid unsafe conditions.

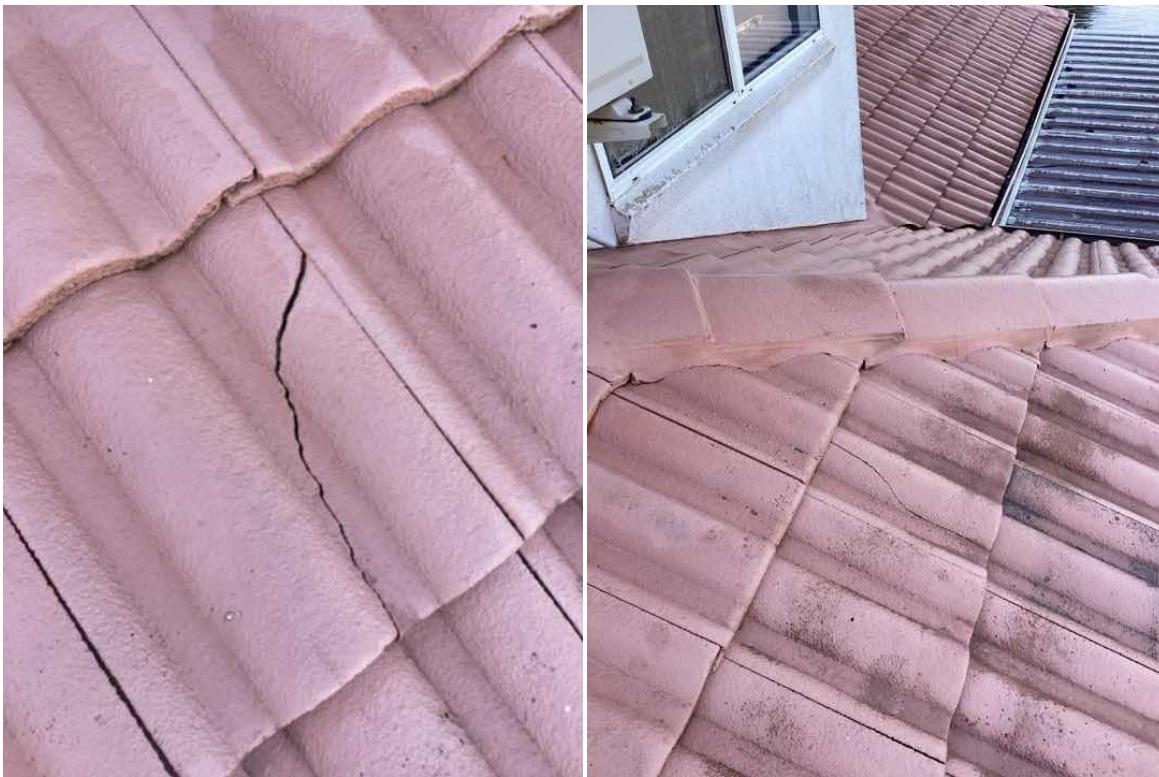
Cracked tiles visible. Contact a roof tiler for repairs. This has potential to become a serious issue if repairs aren't carried out due to water ingress into the roof cavity.

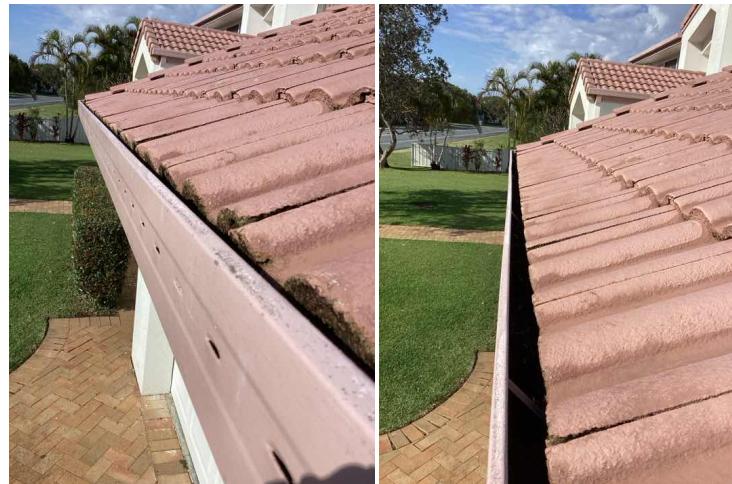
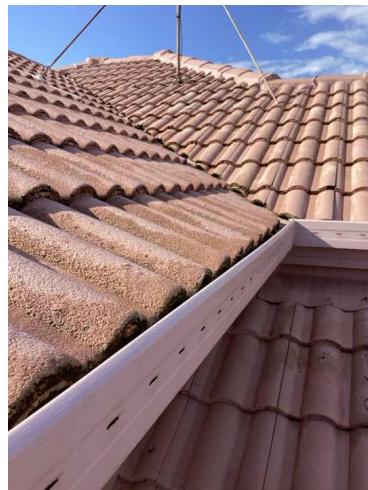
Gutter surface rust in sections- the rust is yet to penetrate and repairs/sealing may be an option. A qualified roof plumber should be engaged for advice and recommendations.

Gutter rust/penetrations- The guttering has excessive rust where leaking will occur. The gutters require replacement by a roof plumber.

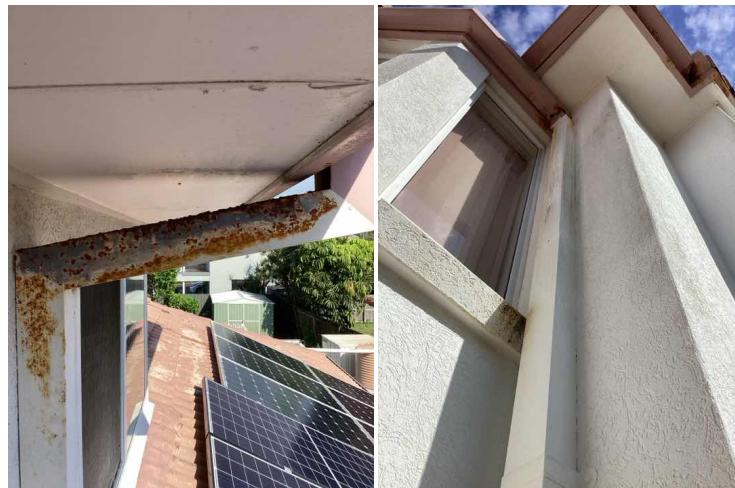
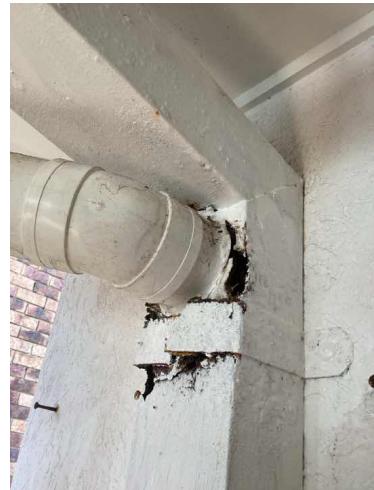
Leaking downpipe joins visible. This can be conducive to termite infestation and cause water damage to cladding over time. A qualified roof plumber should be engaged to repair.

Rust penetrations observed to downpipe. Over time this has potential to cause differential settlement to the footings, cause rising damp and is also conducive to termite infestation. A qualified plumber should be engaged for advice and recommendations.

Minor downpipe rust visible. A qualified plumber should be engaged for advice and recommendations.

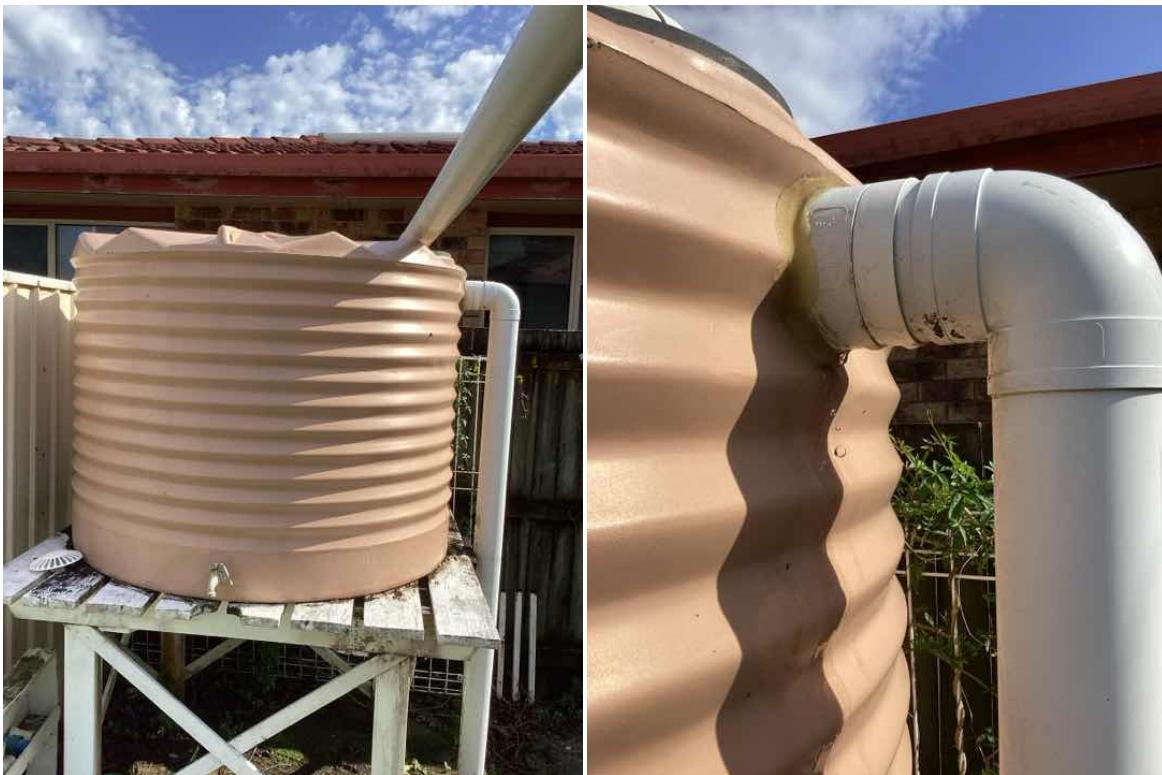
Leaking section. Recommendations: Assessment conducted by a licensed plumber advised.

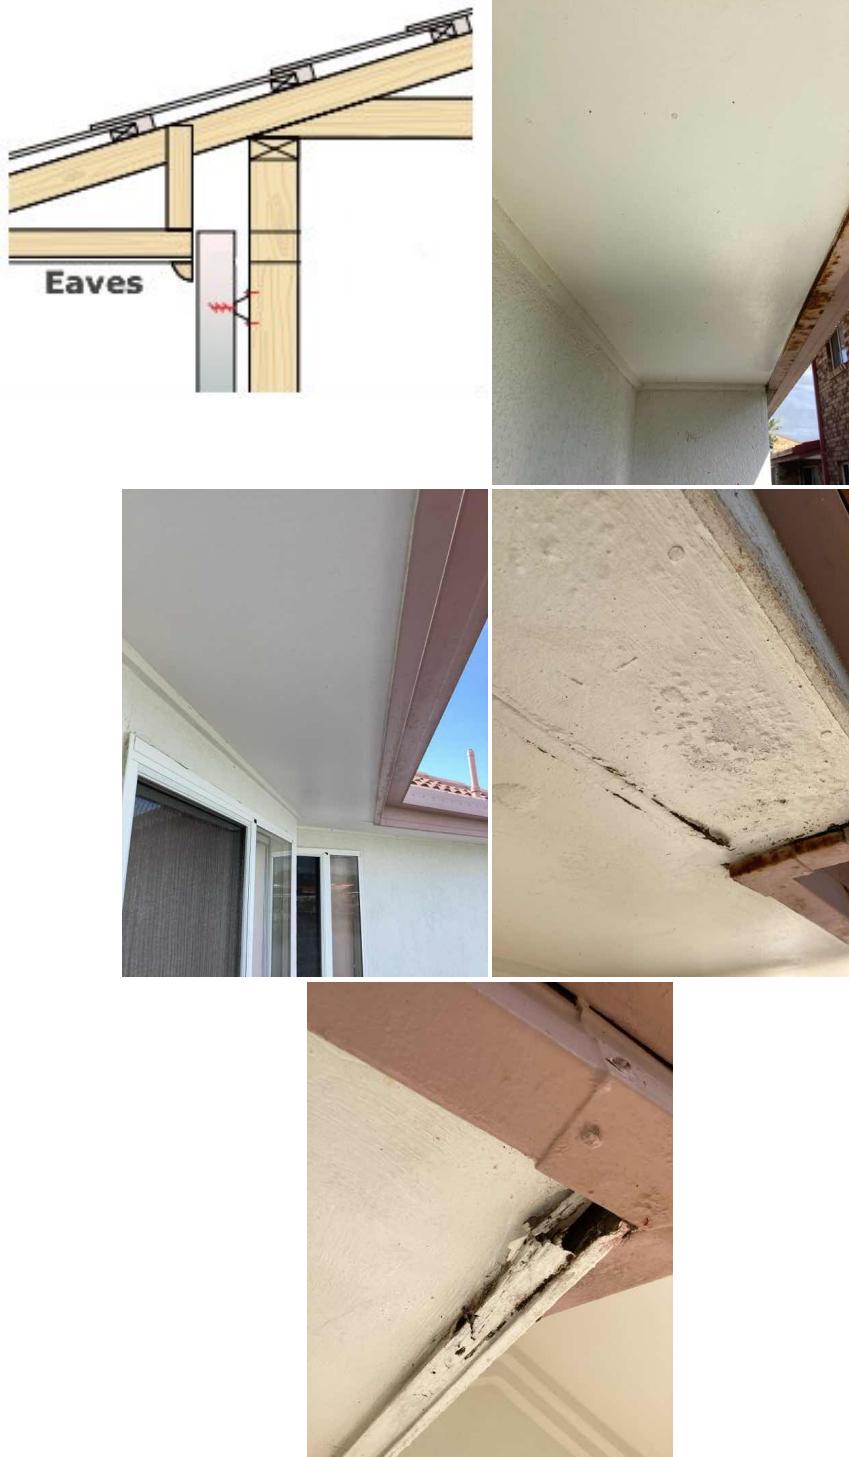
Minor eave deterioration & ageing evident. Recommendations: Maintenance works, general upkeep should be carried out.

Bubbling eave lining paint. Normally due to overflowing/blocked or leakage guttering. A qualified roof plumber should be engaged for advice and recommendations.

Eave lining timber fungal decay visible. Recommendations: A qualified carpenter should be engaged for repairs and recommendations.

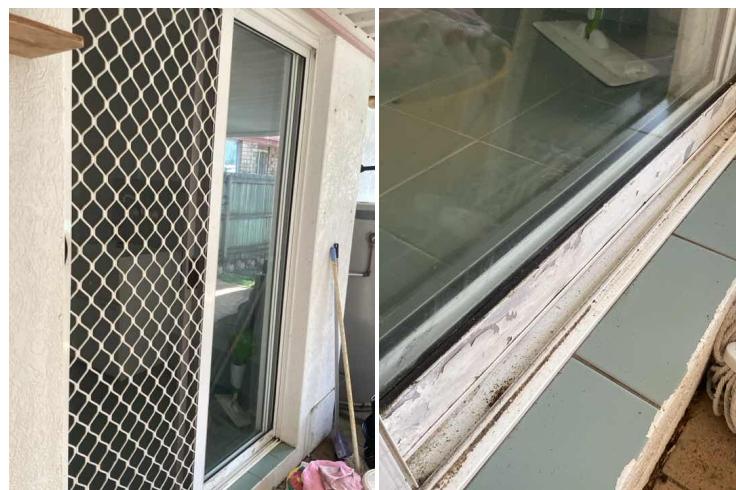
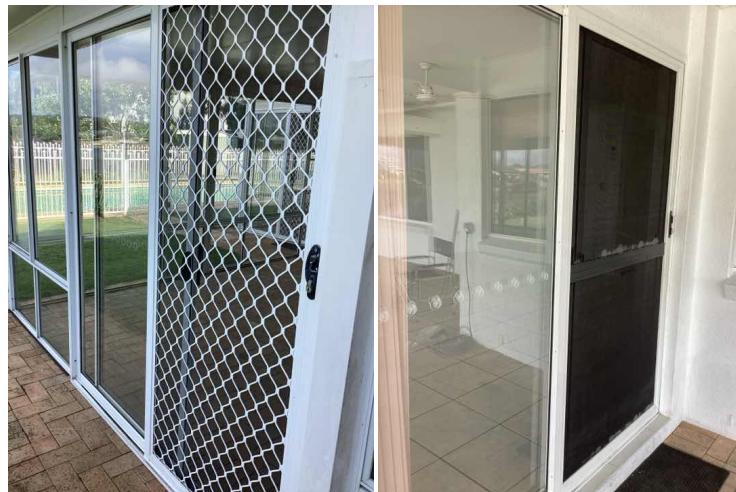
General age/damage has occurred to door frame, face or components. Recommendations: A qualified carpenter should be engaged for advice and recommendations.

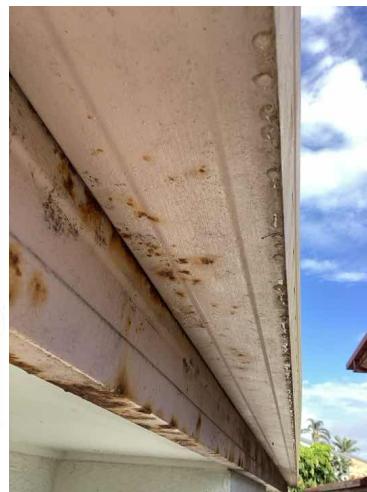
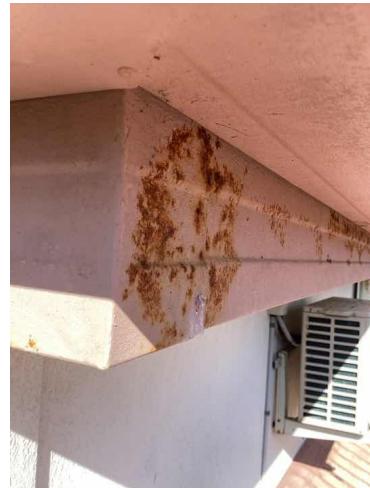
Paint / finish was deteriorated in areas and is in need of maintenance - Sanding back affected areas and painting required.

Rust evident in area/s. Recommendations: Have assessed by contractor with view of restricting/repairing and sealing affected areas.

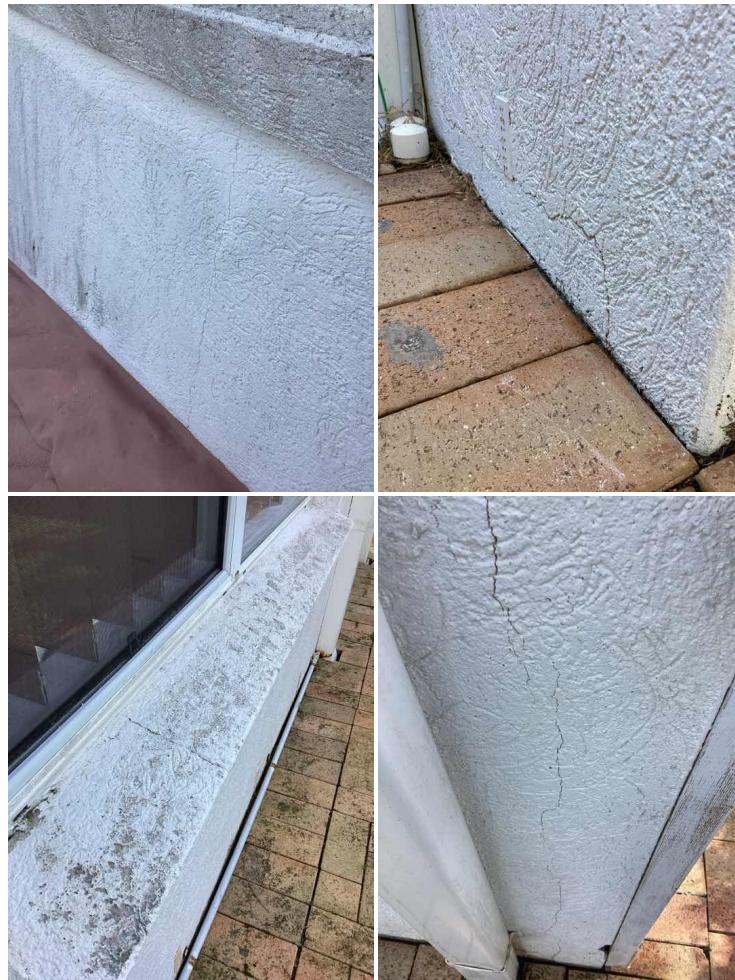
There appears to have been some settlement in the building which has caused some cracking to the walls. These cracks are categorized as 0 to 2. This can also cause some doors to bind or be out of square. In the inspectors opinion these cracks are due to settlement, usually due to ground movement and subsequent movement to building materials can be expected. Any cracks should be monitored

Render bubble/flake deterioration on wall visible possible rising issue (See rising Damp section) -  
Recommendations: Engage a renderer for advice and recommendations.

The external paint has deteriorated. External wall paint preserves and protects the building elements. Contact a qualified painter for repairs.

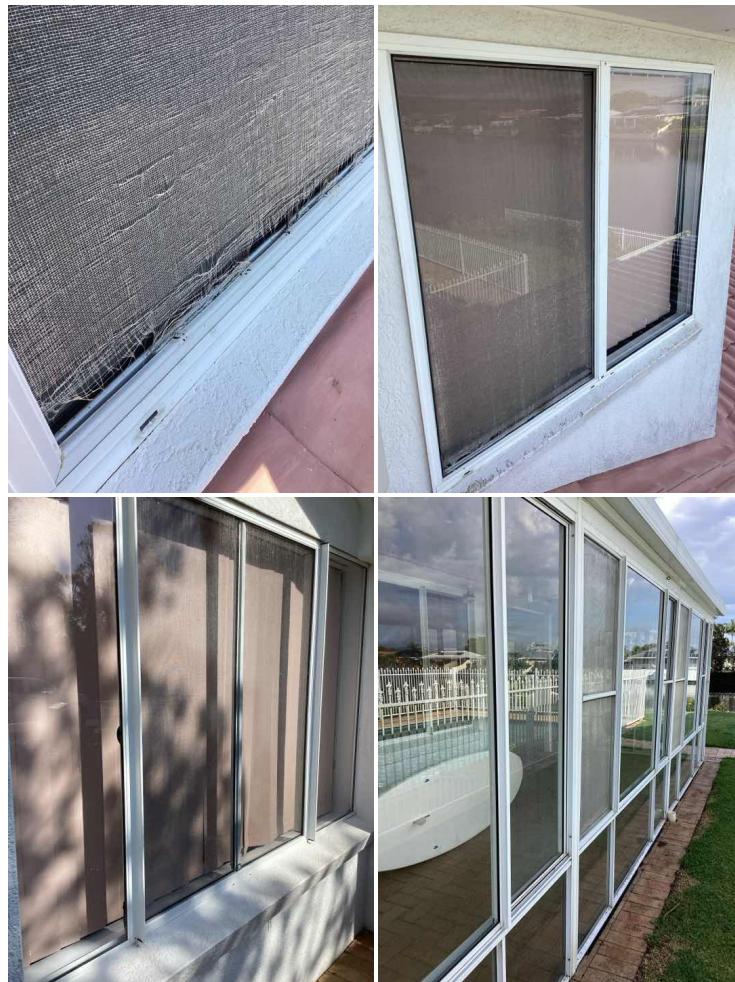
General age/damage has occurred to window components. Recommendations: Restoration work recommended. A qualified carpenter should be engaged for advice and recommendations.

Damaged fly screen/s replace as required.

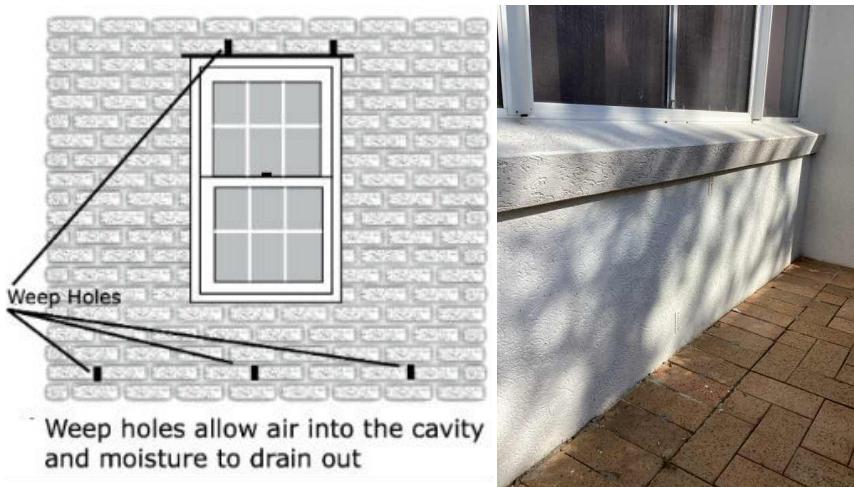
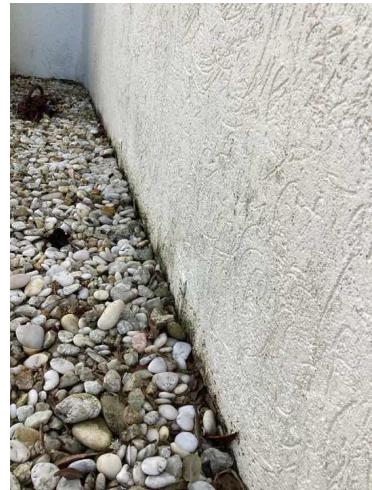
Some weep holes partially are covered - Recommendations: Lower finished ground levels to fully expose all weep holes on the lower brick courses around the dwelling.

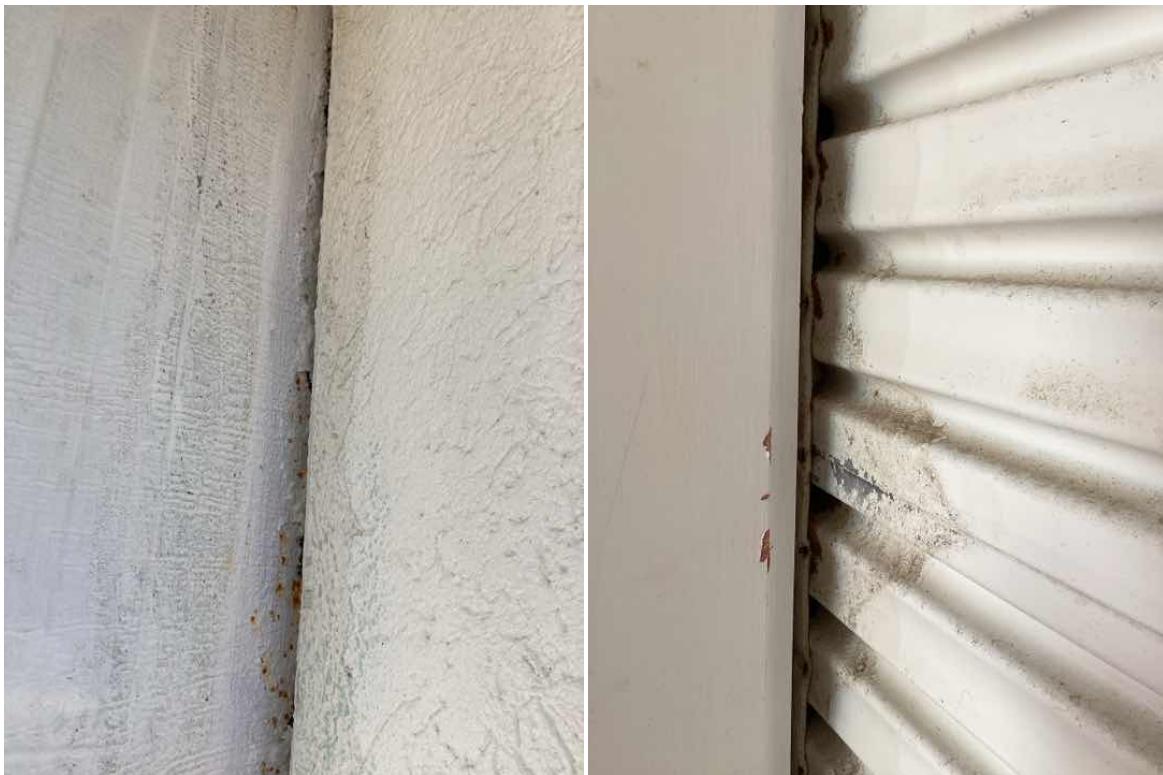
Rust in garage door frame noted - General repair required.

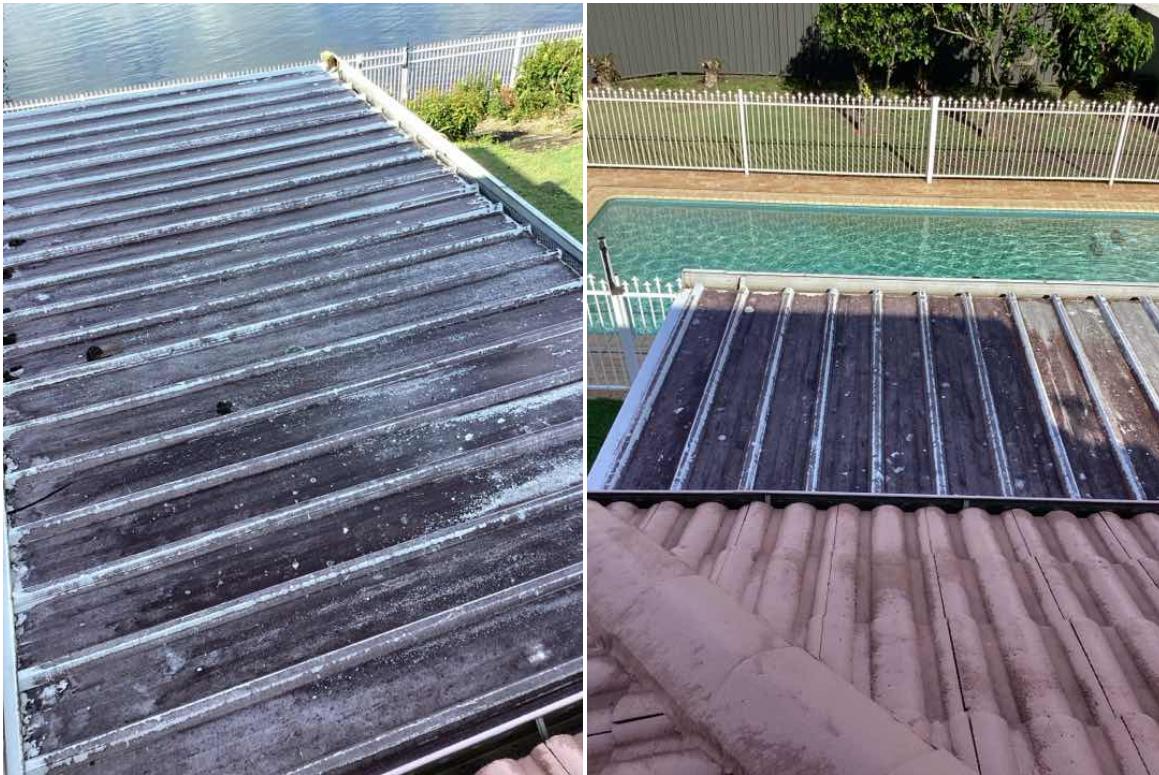
Roof cladding deterioration A qualified roofing contractor should be engaged for advice and recommendations.

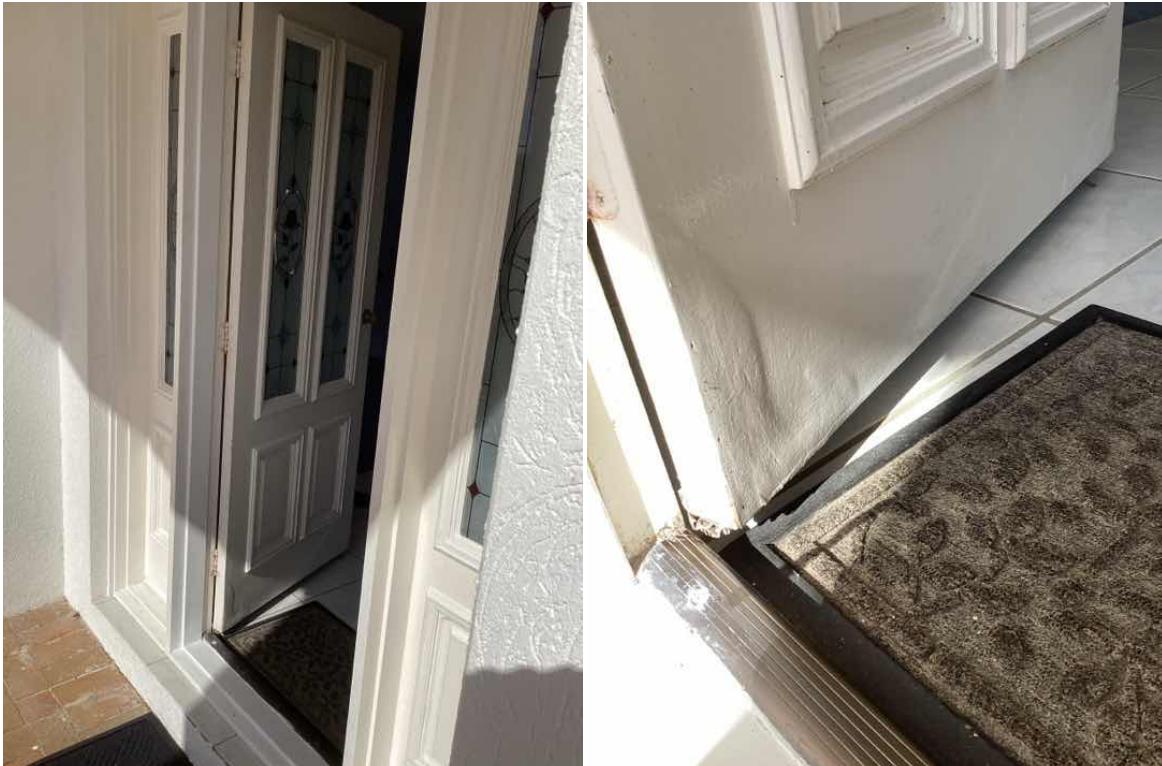
Entry door / frame deterioration - General age/damage has occurred to door frame, face or components. A qualified carpenter should be engaged for advice and recommendations.

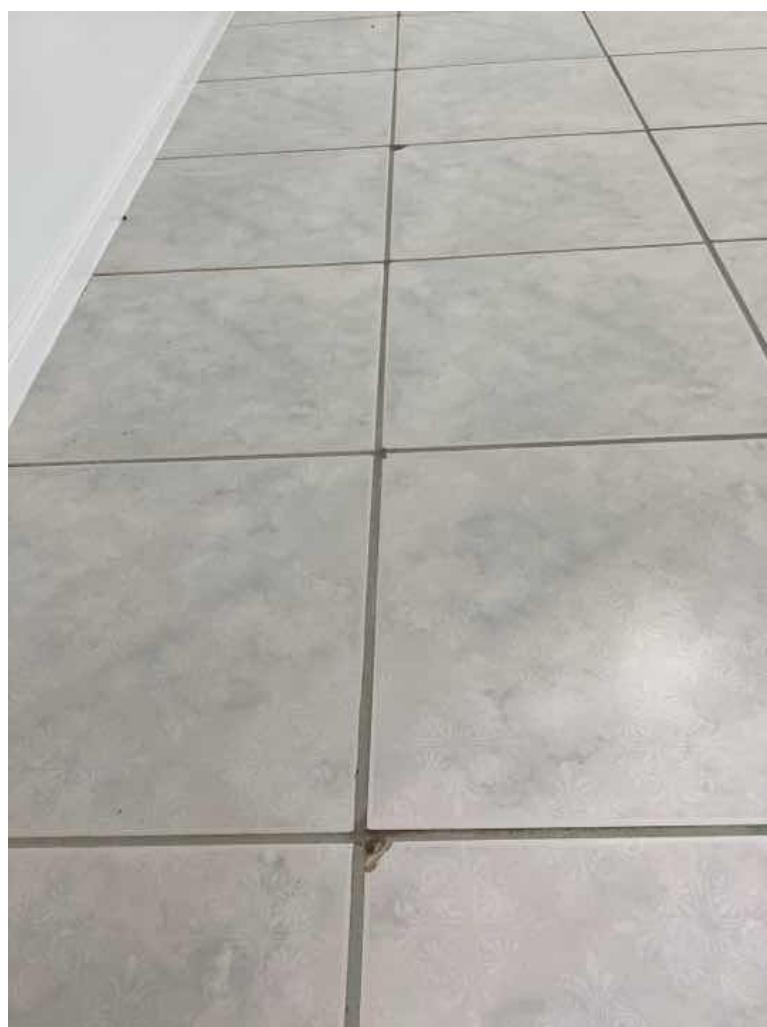
Some chipped and damaged tiled were noted. Replacement recommended by a qualified tiler

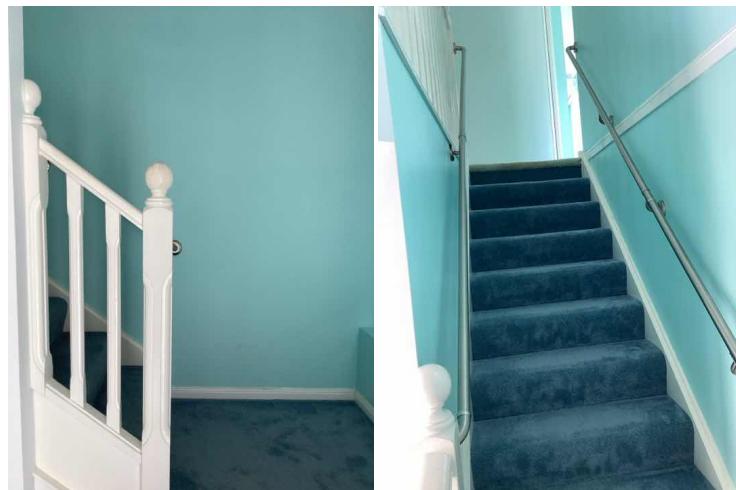
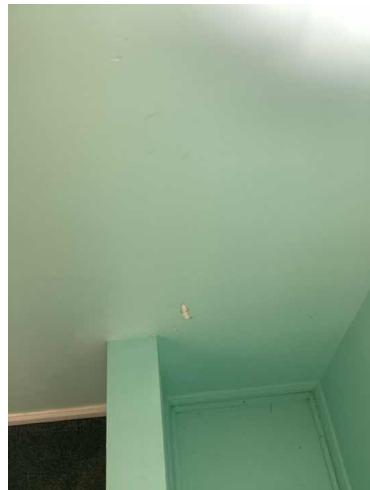
Impact damage to wall noted. Patch and paint will generally suffice, however see a qualified painter for further advice.

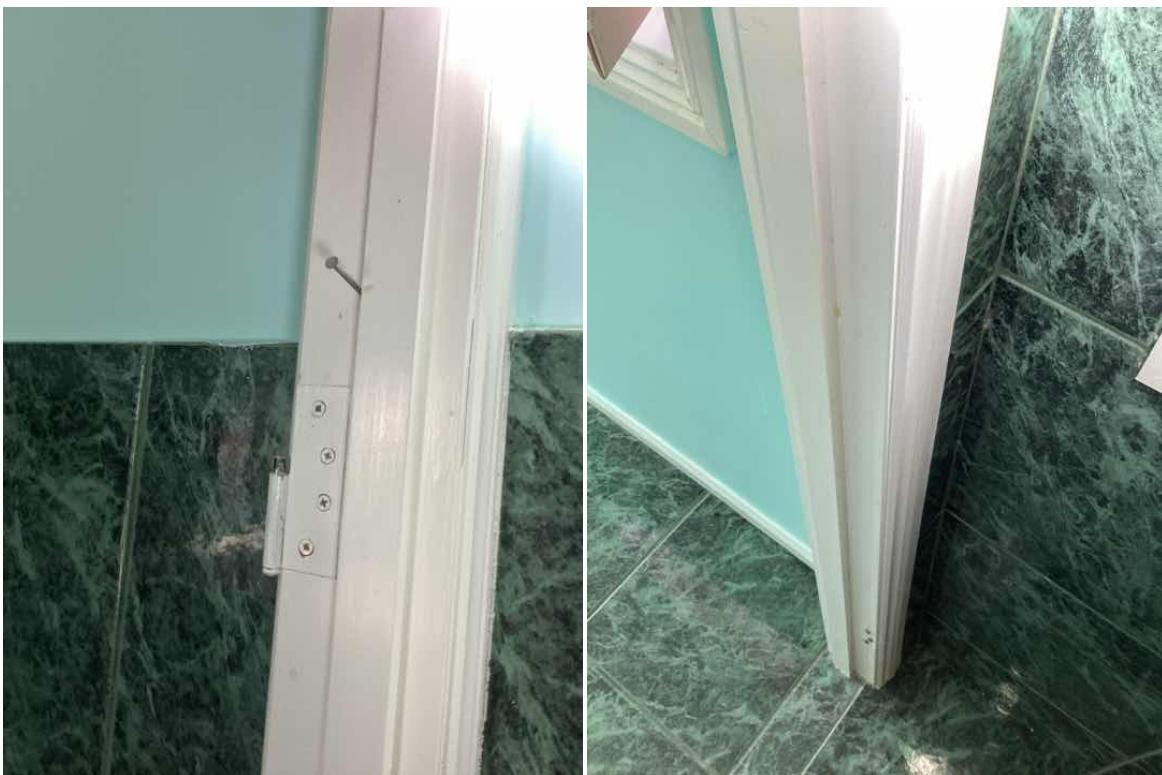
Toilet door is missing/not installed. Contact a qualified carpenter for repairs.

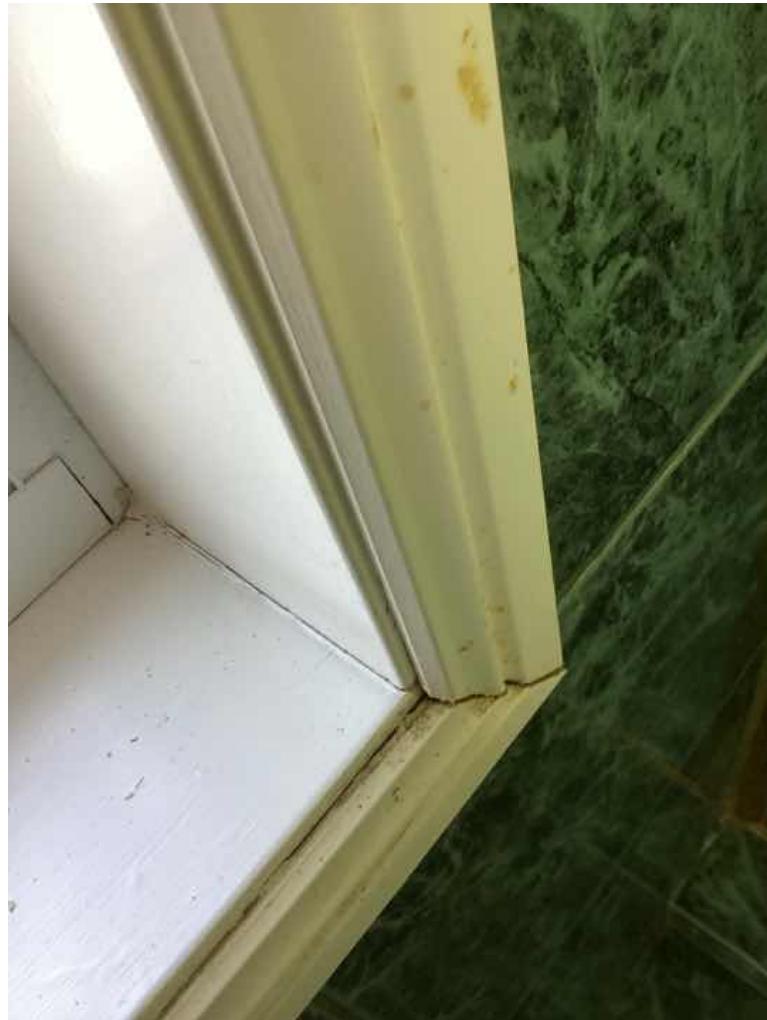
General age wear deterioration - The window frame/components showed evidence of ageing and wear. General maintenance works required.

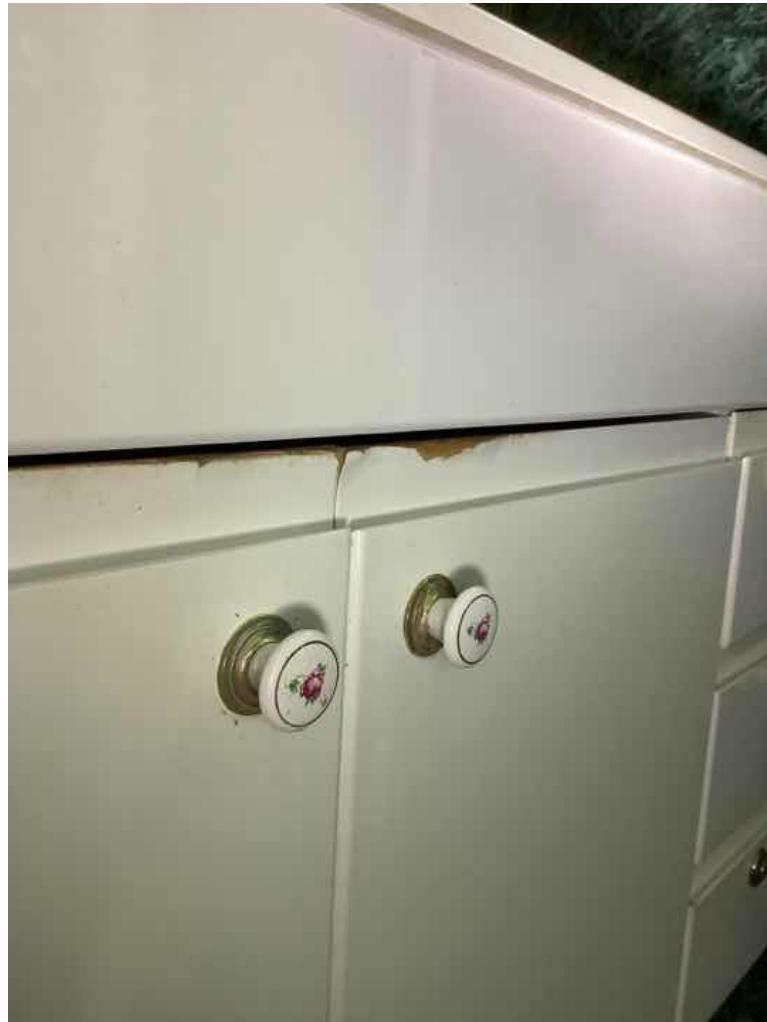
General deterioration and wear to vanity, cupboards and benches.

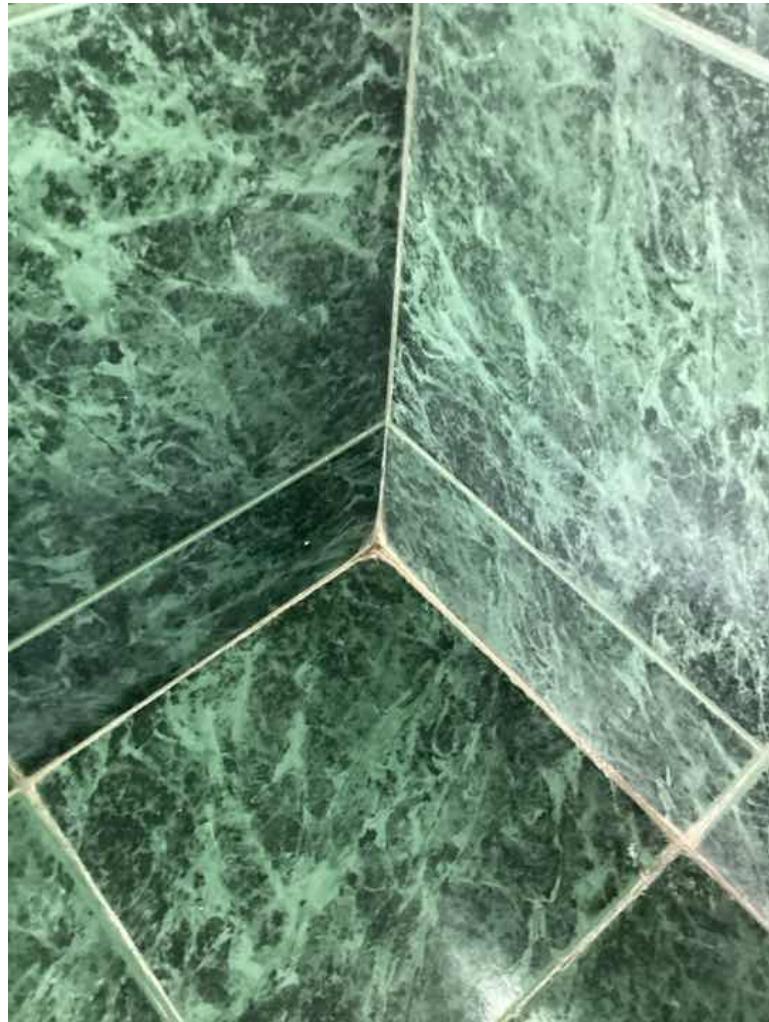
Tile grout deterioration to tiles to the shower area. Re-grout / seal. A qualified tiler should be engaged recommendations and repairs as water may seep in causing rot and creating conducive conditions for termites.

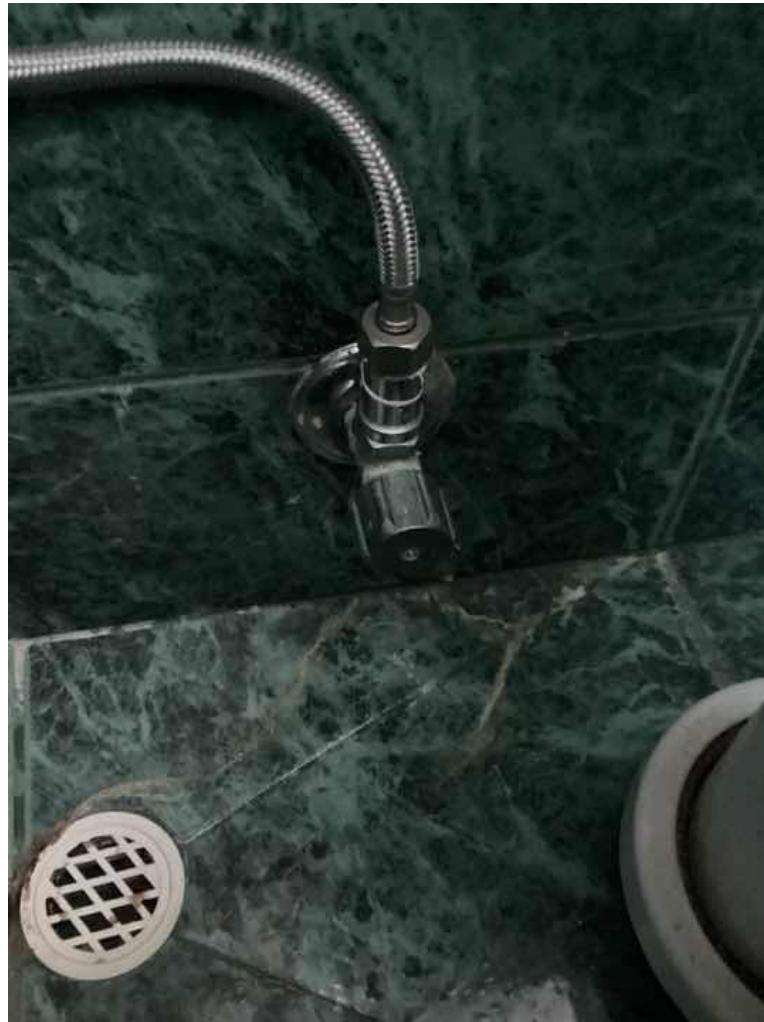
The cistern is leaking and should be repaired. Contact a qualified plumber for repairs.

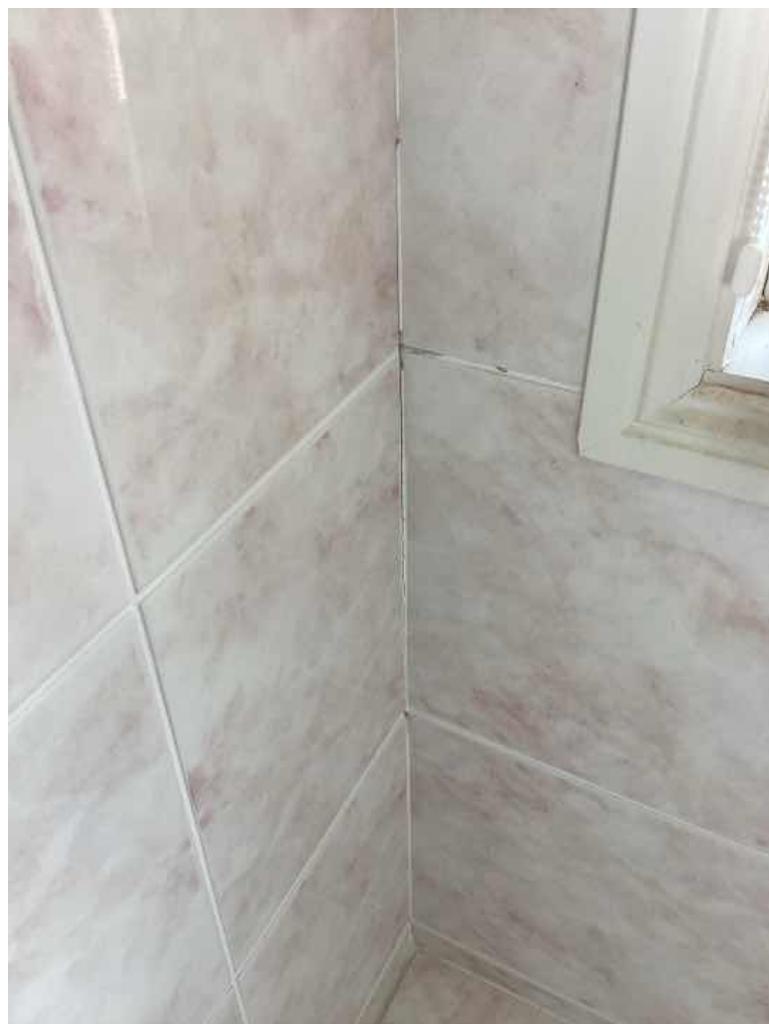
Deteriorated grout noted. This should be repaired as this will lead to water ingress under the tiles causing uplifting and possible water penetration.

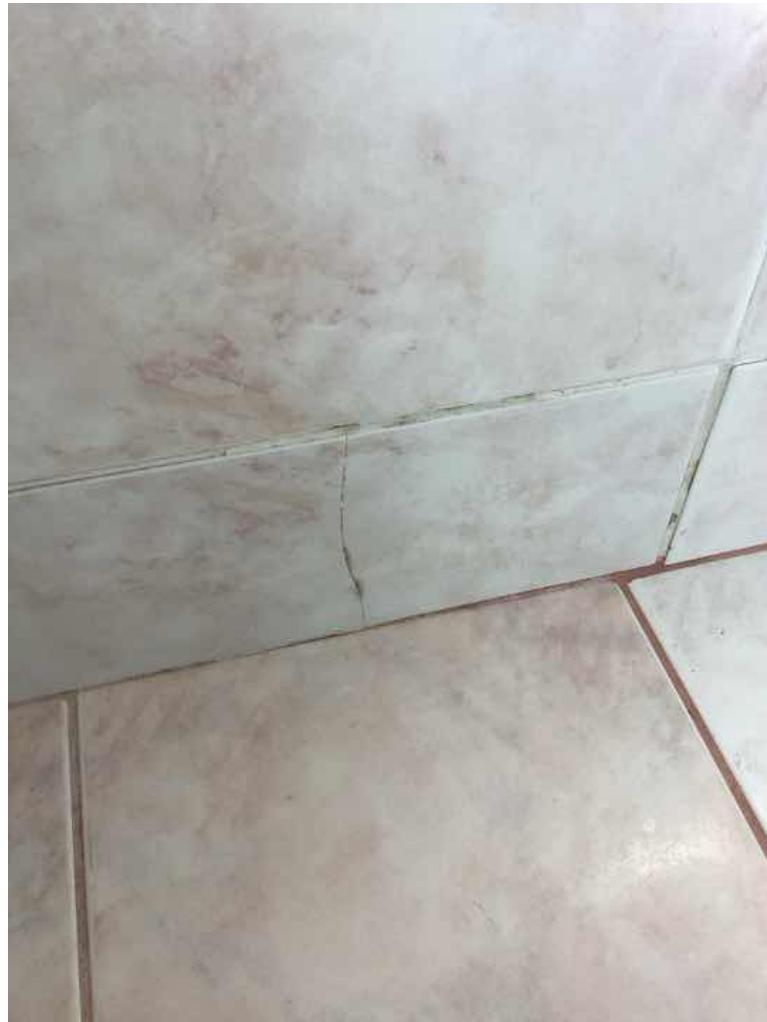
Cracked tile/s noted. This can cause extensive floor and floor frame damage and is conducive to termite infestation if water is leaking through the cavity. A qualified tiler should be engaged for advice and recommendations.

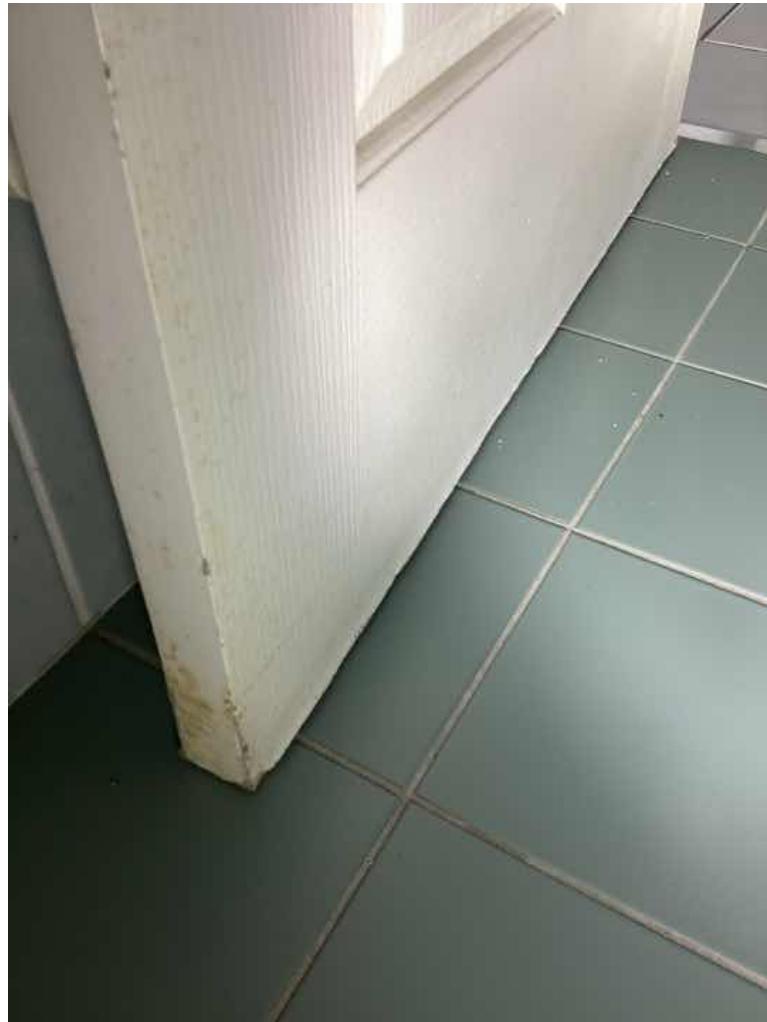
Door / frame deterioration - General age/damage has occurred to door frame, face or components.  
Recommendations: A qualified carpenter should be engaged for advice and recommendations.

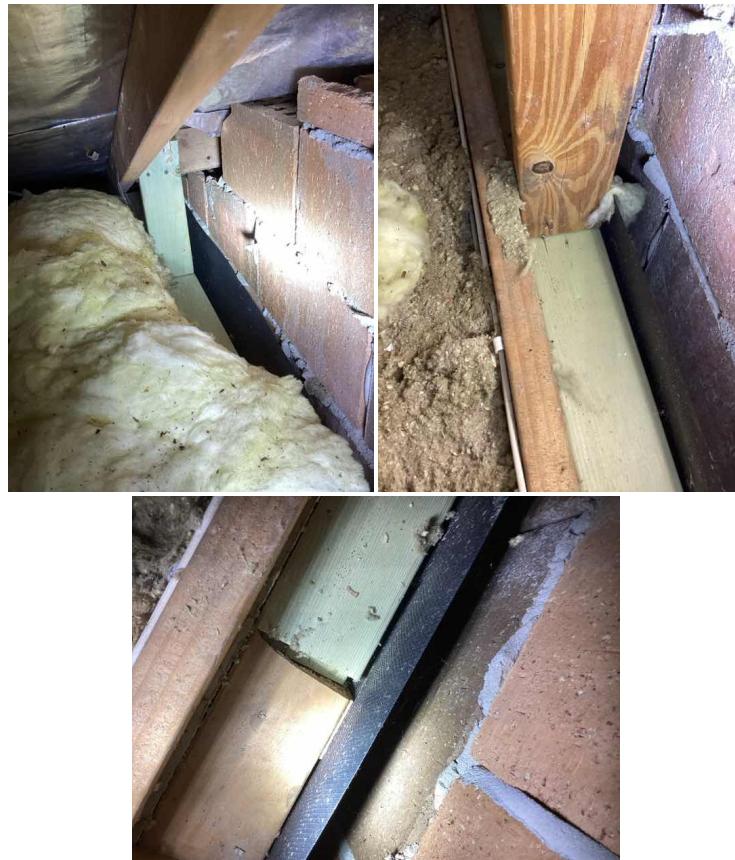
Timber pest attack noted. Contact a qualified pest controller for treatment in accord with AS 3660 and a licensed builder for advice on repair work.
