# Inspection Report

## Ultimate Building & Pest

**74 Overall Drive, Pottsville, NSW, 2489**

## Pest And Building Inspection

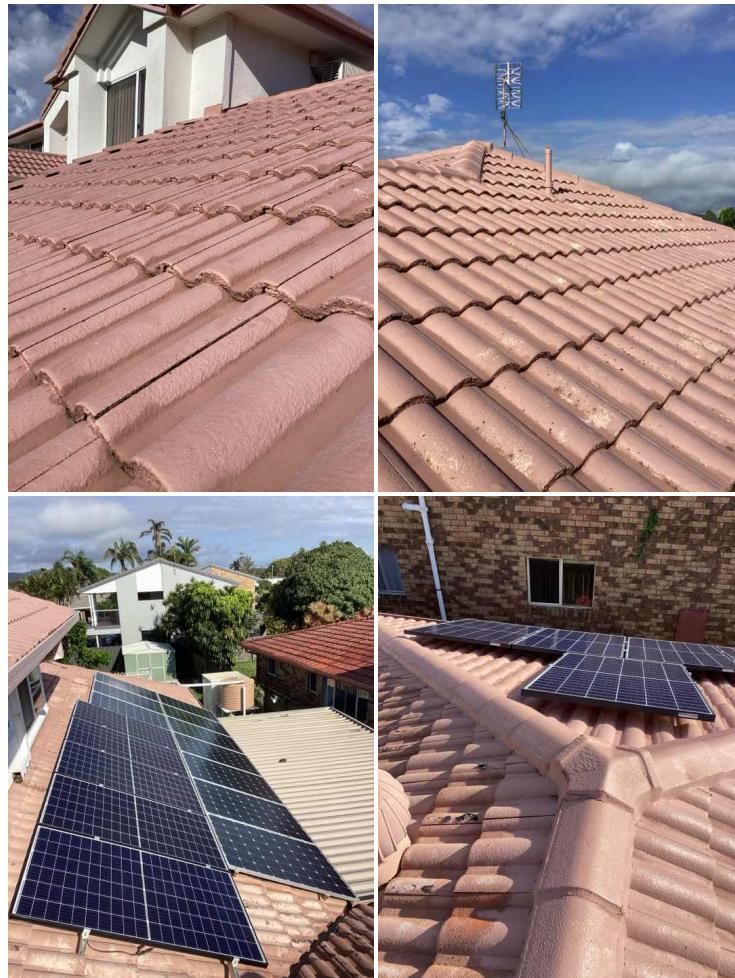
Of the visible areas, the general condition of the roof is in serviceable condition for the age.  
Note: In the absence of rainfall there is no guarantee that the roof won't leak.

Visible section of The roof cladding appeared in a serviceable condition for the age of this dwelling. Annual maintenance inspection recommended.

Cracked tiles visible. Contact a roof tiler for repairs. This has potential to become a serious issue if repairs aren't carried out due to water ingress into the roof cavity.

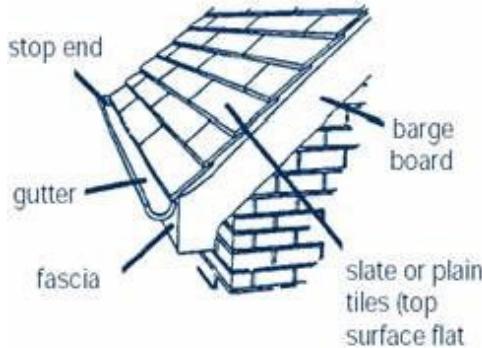
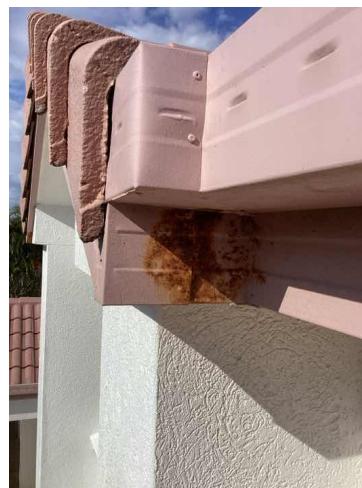
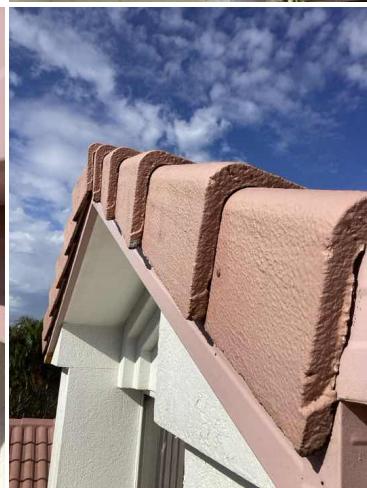
Paint / finish was deteriorated in areas and is in need of maintenance - Sanding back affected areas and painting required.

Rust evident in area/s. Recommendations: Have assessed by contractor with view of restricting/repairing and sealing affected areas.

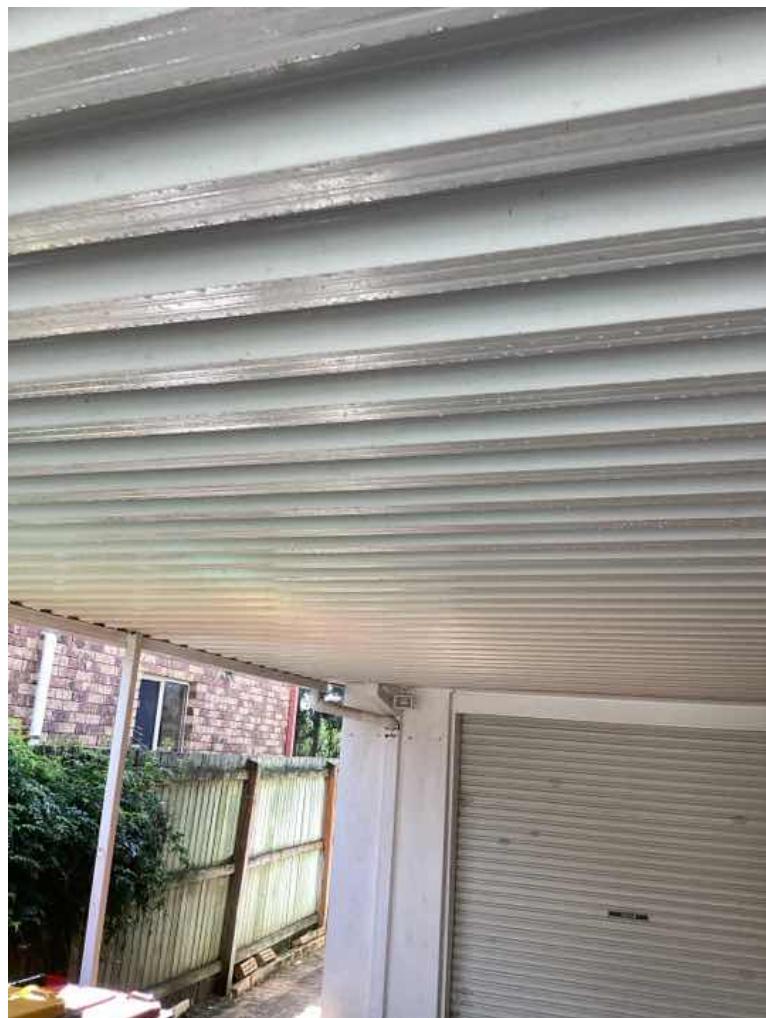
Roof cladding deterioration A qualified roofing contractor should be engaged for advice and recommendations.

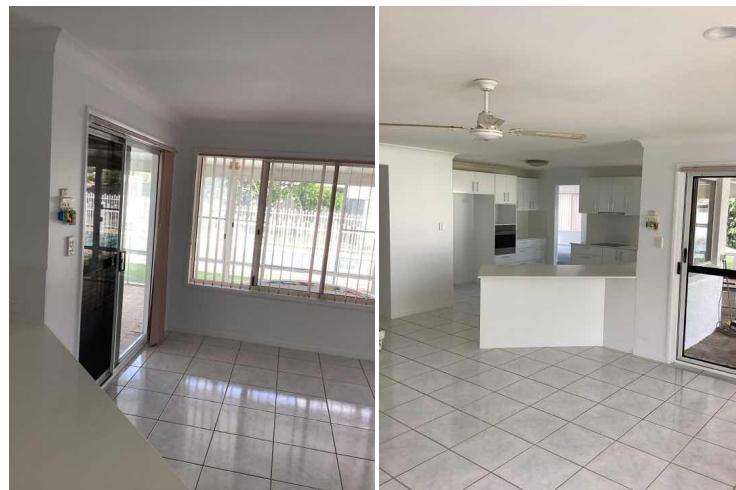
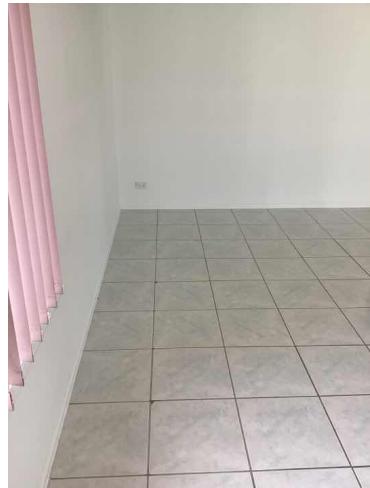
Some chipped and damaged tiled were noted. Replacement recommended by a qualified tiler

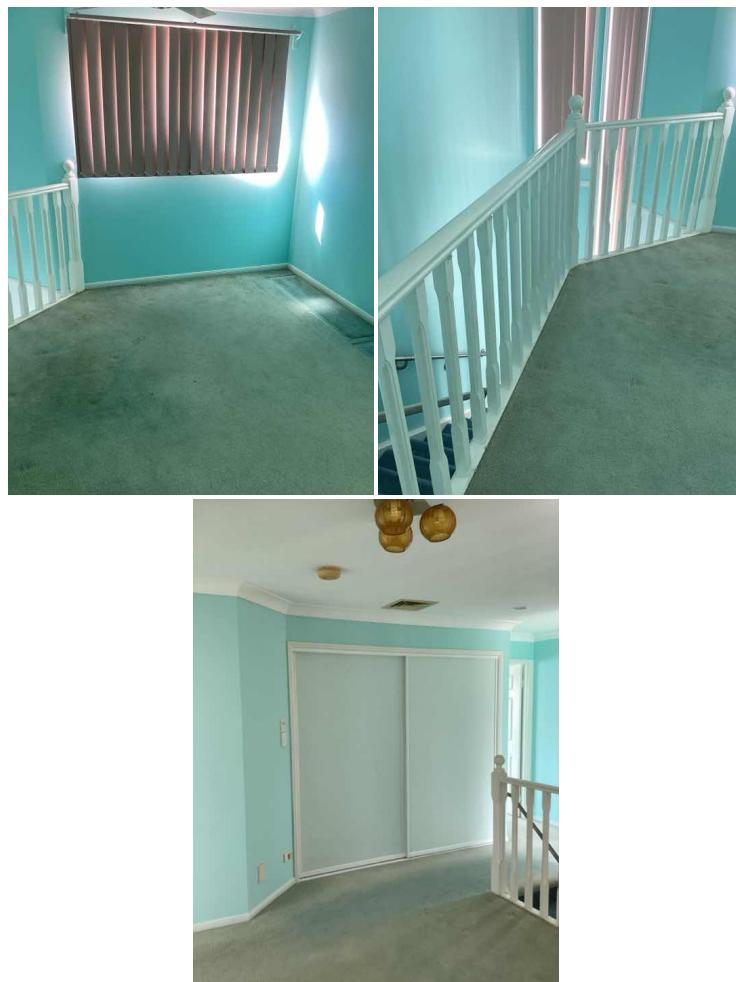
General carpet deterioration. Replacement may be required A qualified carpet layer should be engaged.

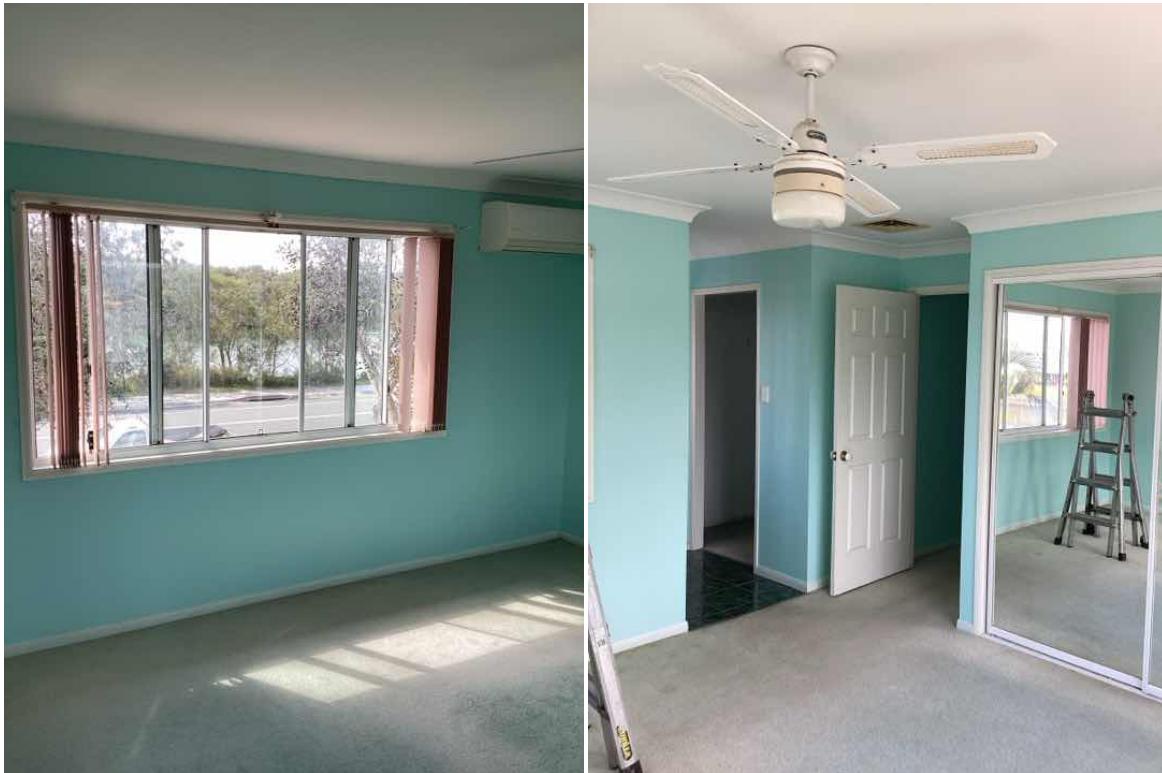
General ageing and/or denting and the like is evident on wall linings - Recommendations: A qualified painter should be engaged to assess and repair as required.

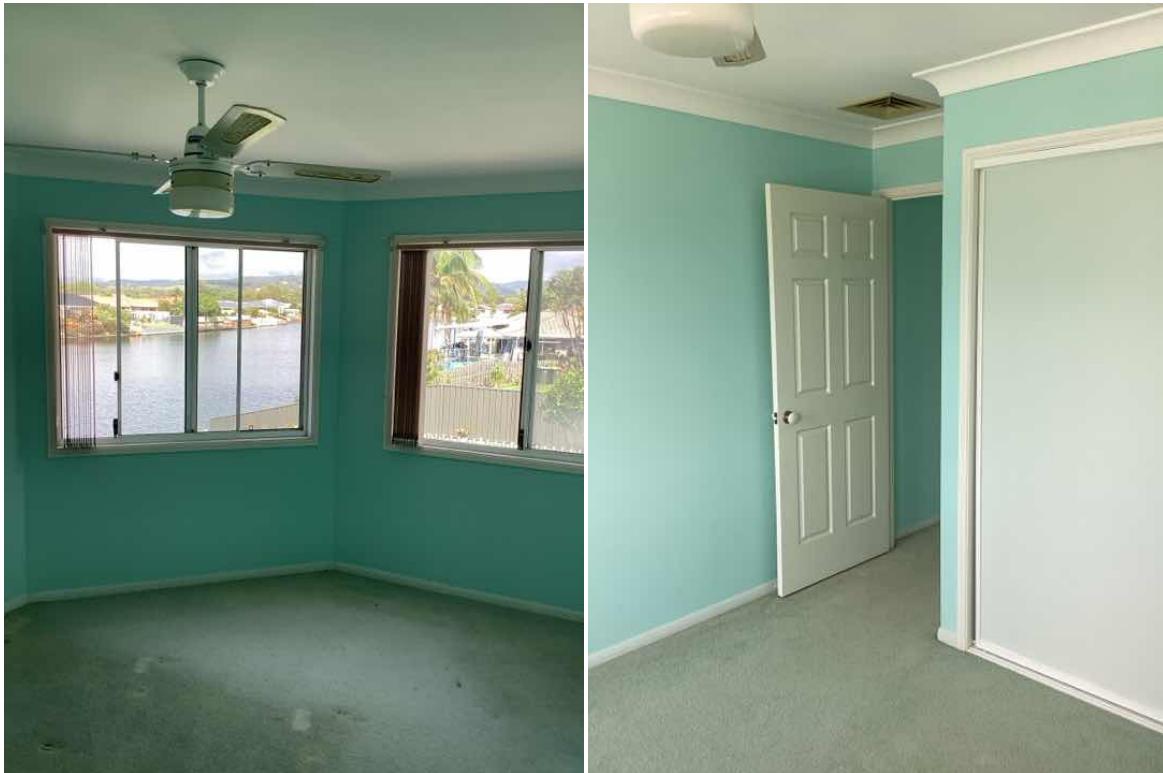
General carpet deterioration. Replacement may be required. A qualified carpet layer should be engaged.

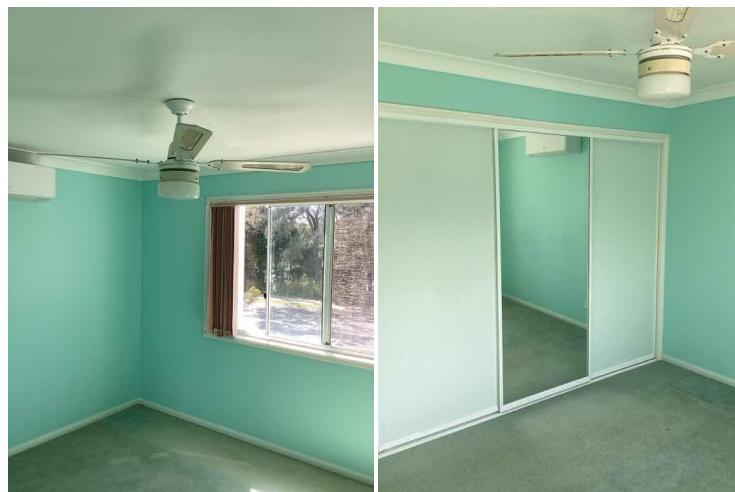
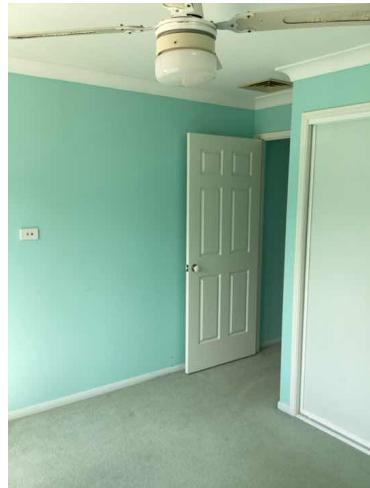
Wall stains observed - No abnormal moisture readings obtained. Recommendations: These may have been repaired, however, you will need to monitor this area and if further staining or flaking appears contact a qualified plumber for further investigation.

Sponginess bounce in flooring sections. There are many reasons for this. A qualified carpenter should be engaged for advice and recommendations.

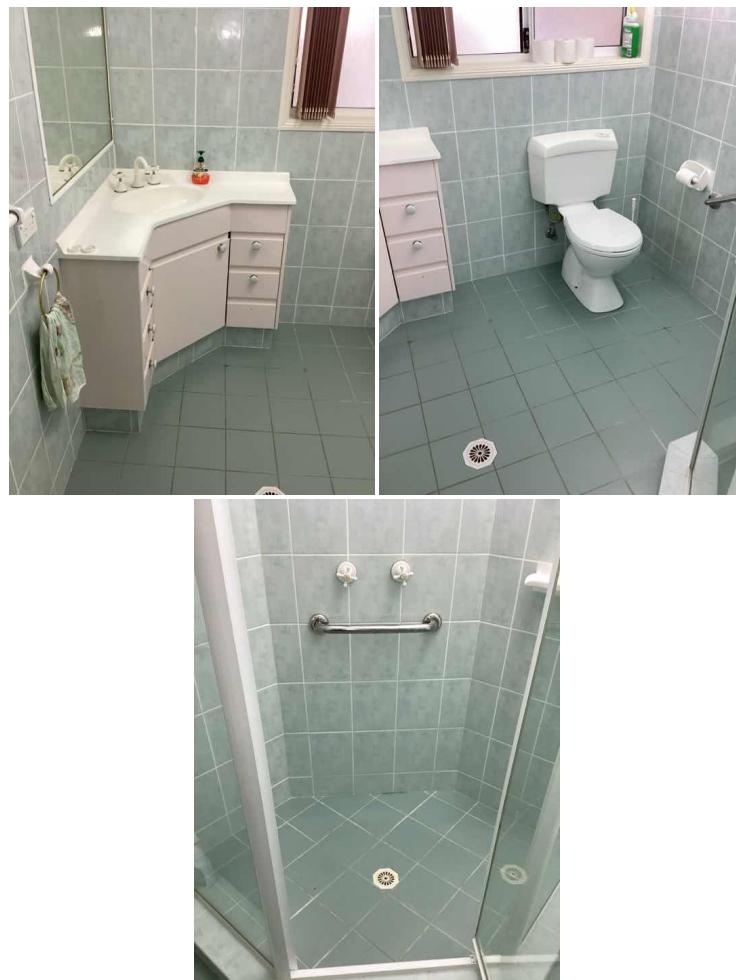
Some chipped and damaged tiled were noted. Replacement recommended by a qualified tiler

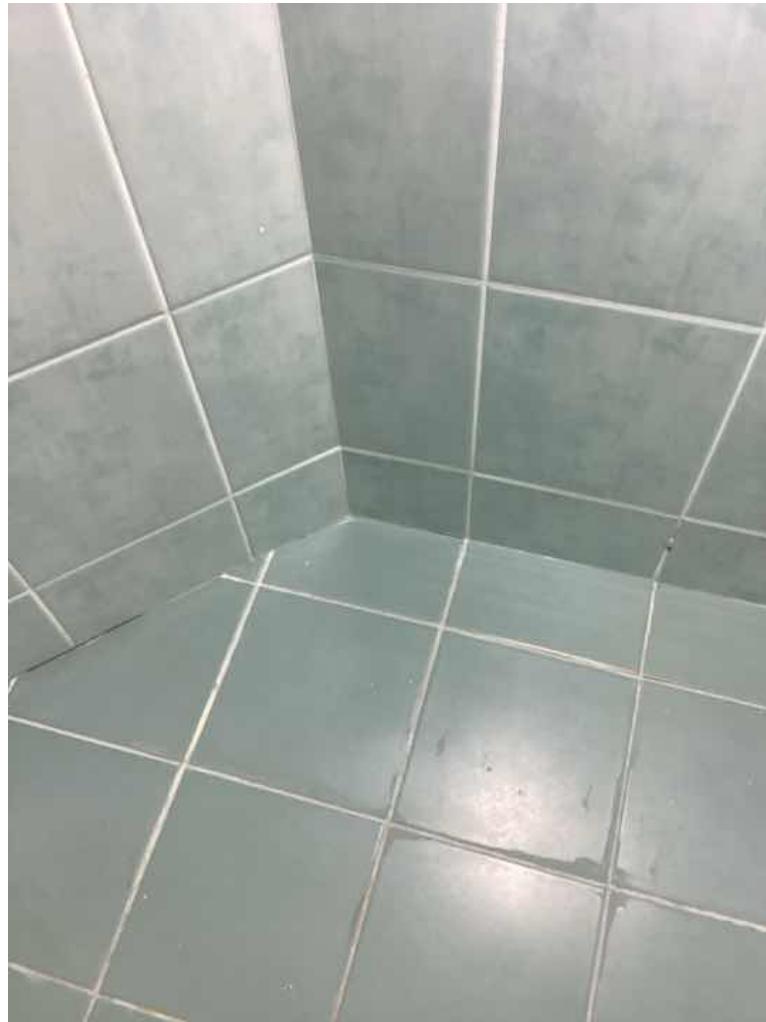
Tile grout deterioration to tiles to the shower area. Re-grout / seal. A qualified tiler should be engaged recommendations and repairs as water may seep in causing rot and creating conducive conditions for termites.

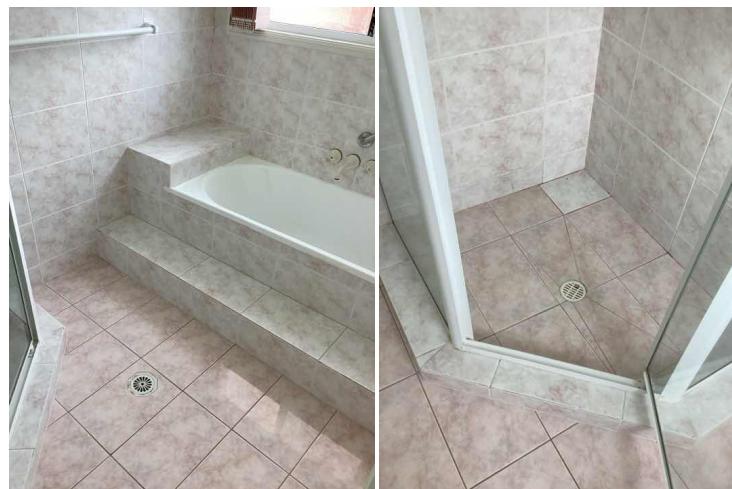
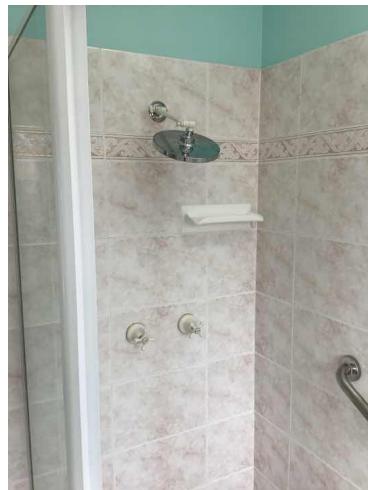
Deteriorated grout noted. This should be repaired as this will lead to water ingress under the tiles causing uplifting and possible water penetration.

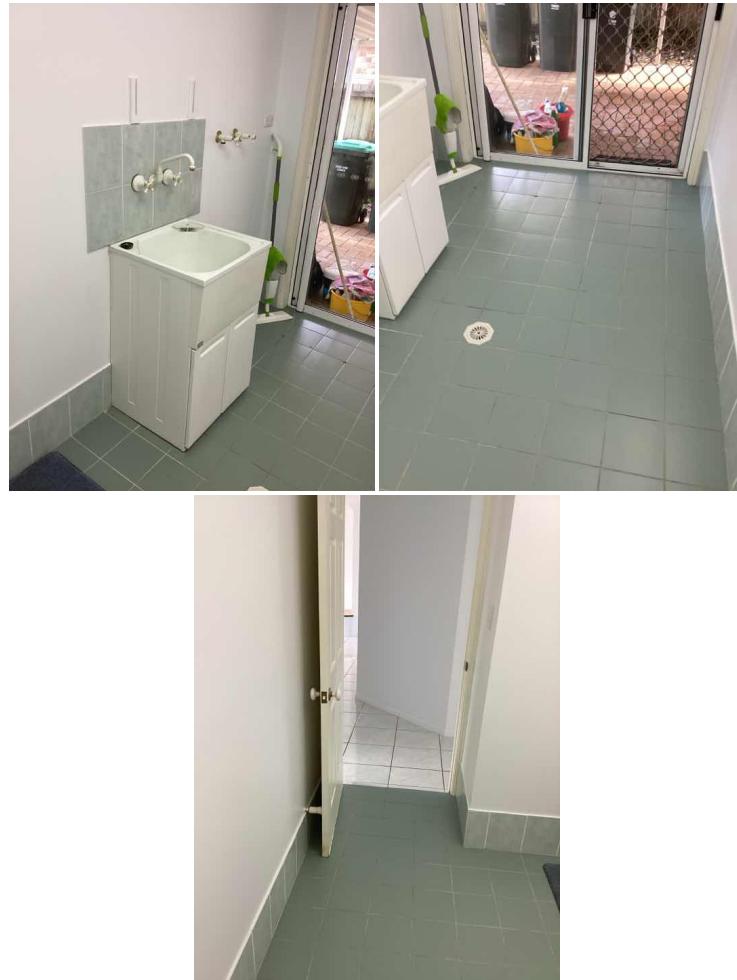
Door / frame deterioration - General age/damage has occurred to door frame, face or components.  
Recommendations: A qualified carpenter should be engaged for advice and recommendations.

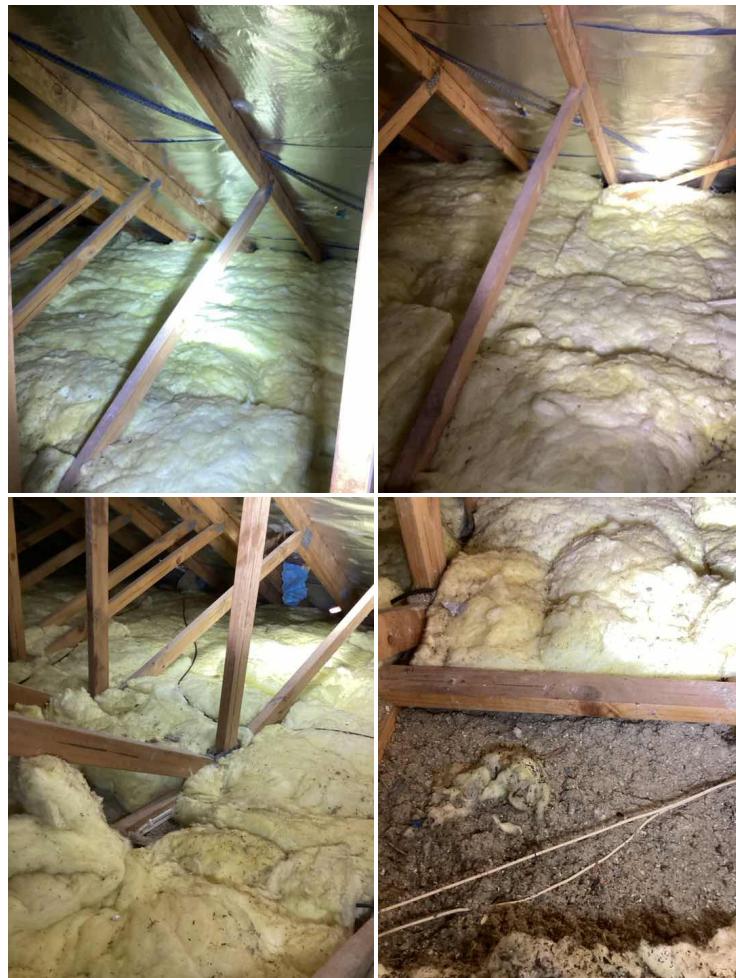
The roof space is insulated with fibreglass batts.

The roof space is insulated with loose fill insulation.

Where visible and accessible, the insulation appears to be in a serviceable condition.

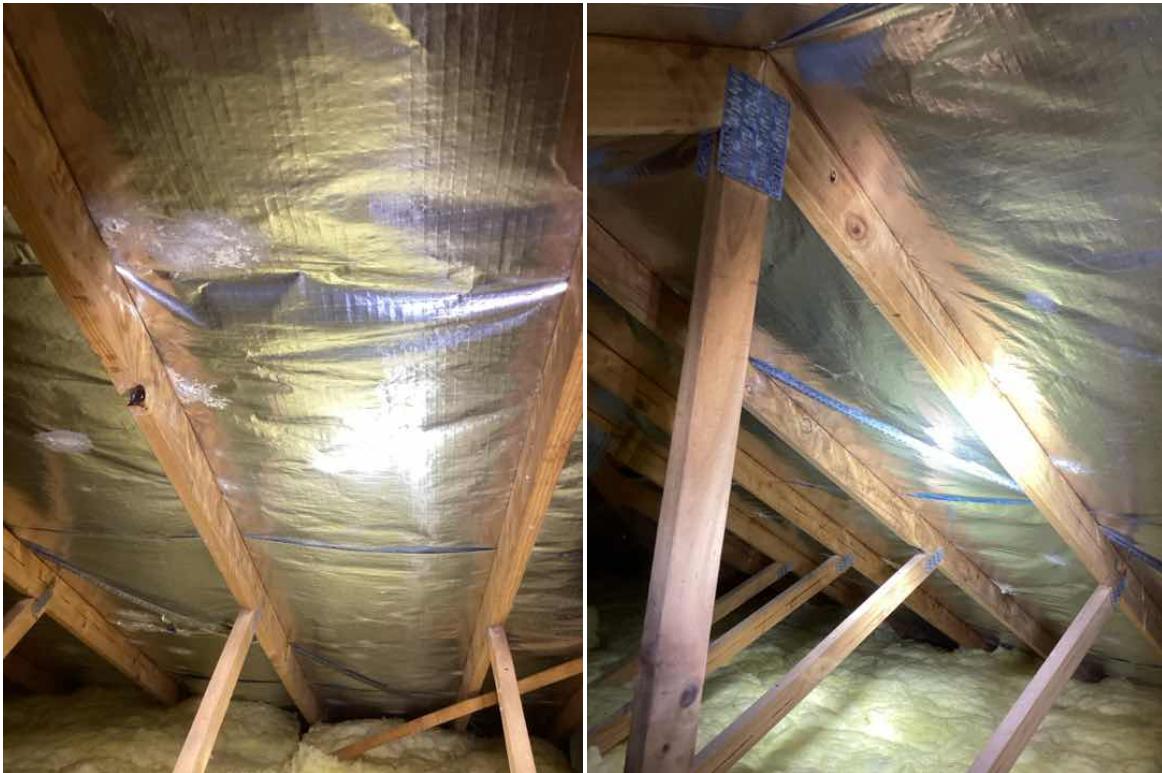
Sarking is installed.

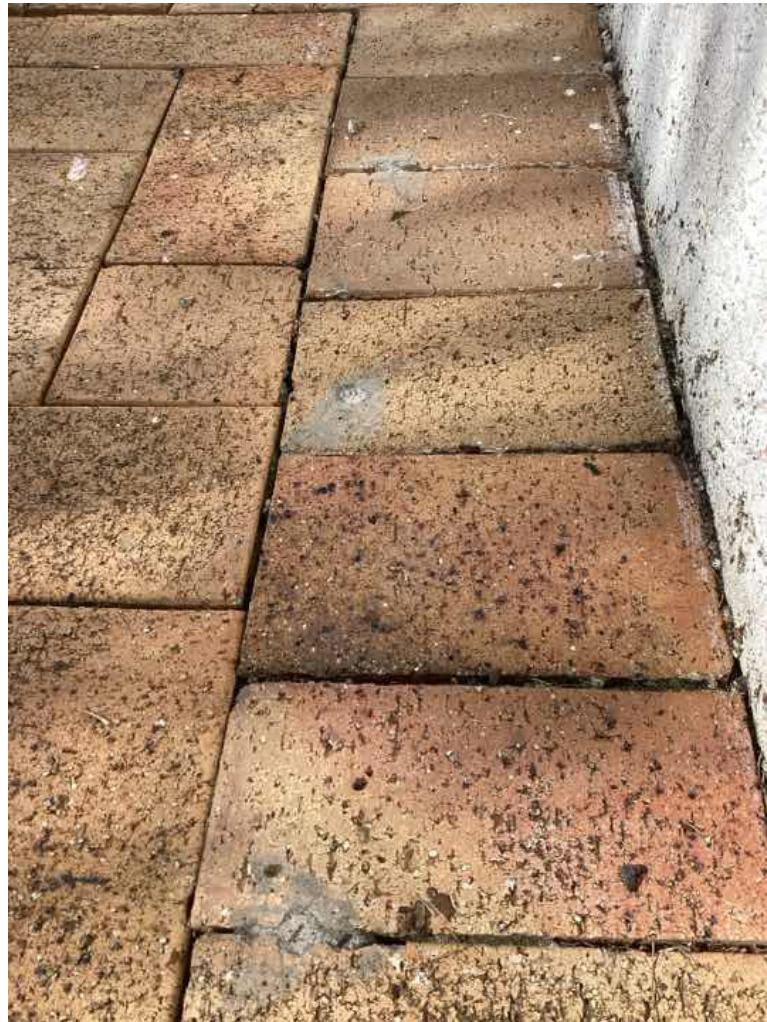
Yes, Drill Holes (Chemical Treatment) were located at the property.

Warning: If evidence of drill holes in concrete or brickwork or other signs of a possible previous treatment are reported then the treatment was probably carried out because of an active termite attack. Extensive structural damage may exist in concealed areas. You should have an invasive inspection carried out and have a builder determine the full extent of any damage and the estimated cost of repairs as the damage may only be found when wall linings etc. Are removed. Normally if a termite treatment has been carried out then a durable notice should be located in the meter box indicating the type of termite shield system, treated zone or combination has been installed.

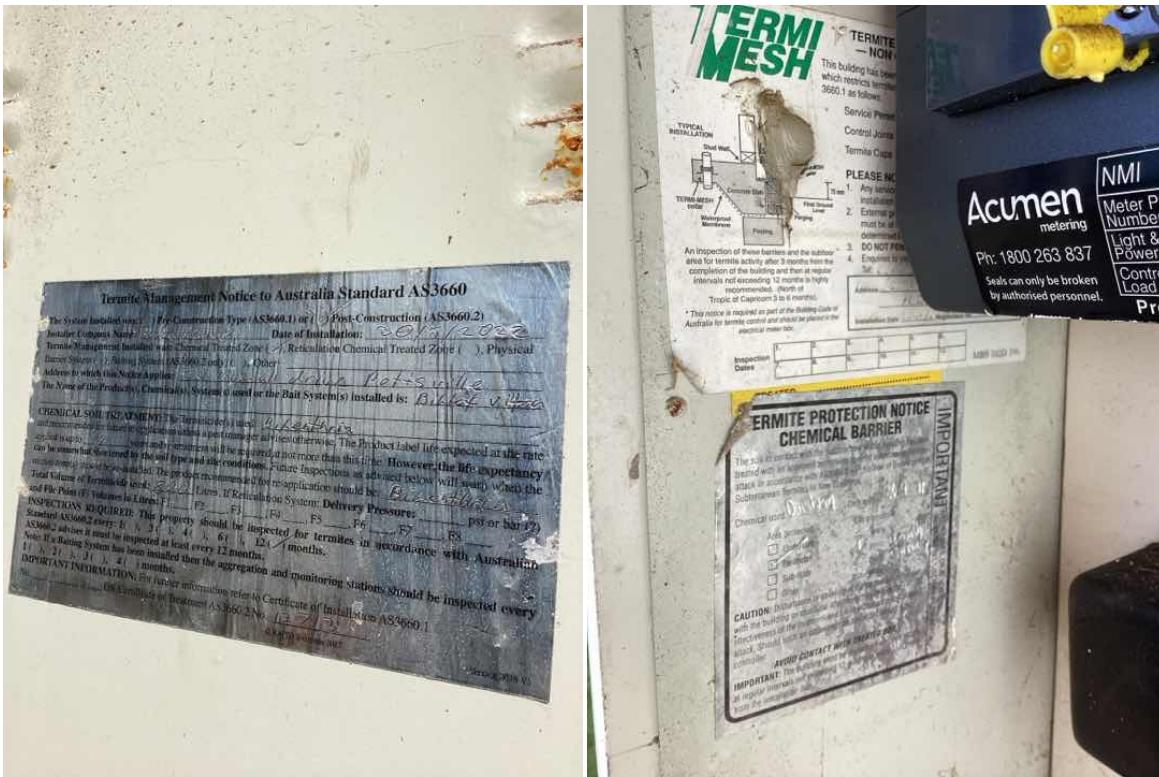
Yes, a durable notice was found in the meter-box during the inspection.

This firm can give no assurances with regard to work that may have been previously performed by other firms. You should obtain copies of all paperwork and make your own inquiries as to the quality of the treatment, when it was carried out and warranty information. In most cases you should arrange for a treatment in accord with Australian Standard 3660 be carried out to reduce the risk of further attack.

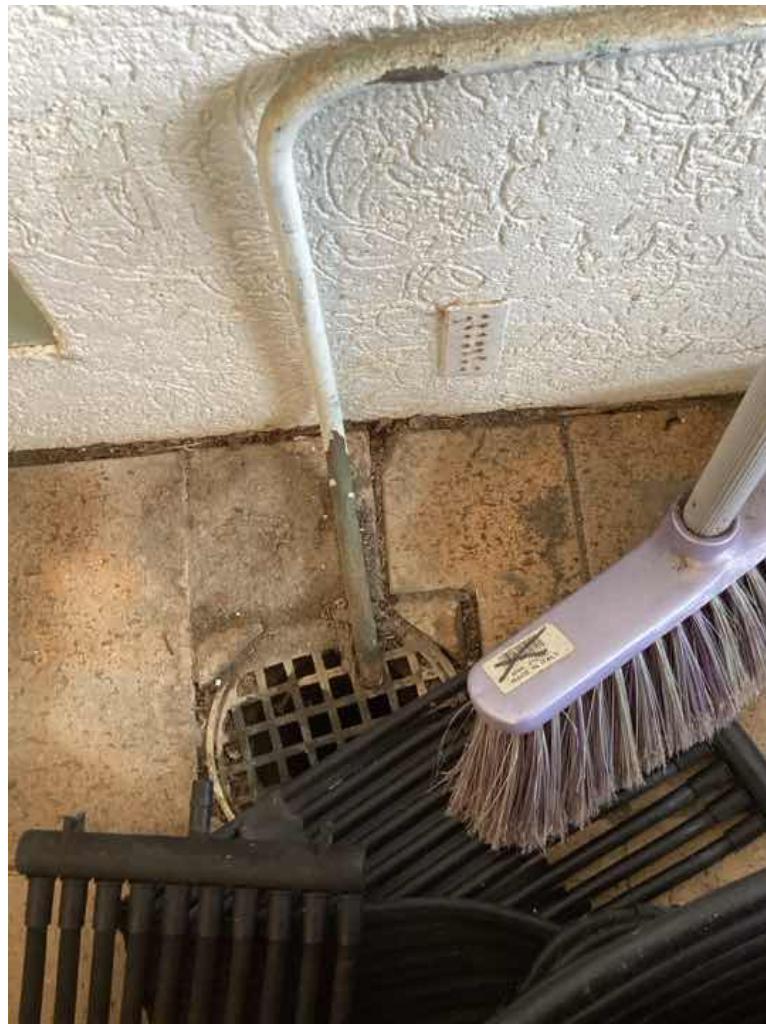
Yes. The hot water overflow does not drain to the perimeter of the building.
